**EXPLODED VIEW**

350 PVT (bleed/relief valve) with diaphragm failure  
(basic)

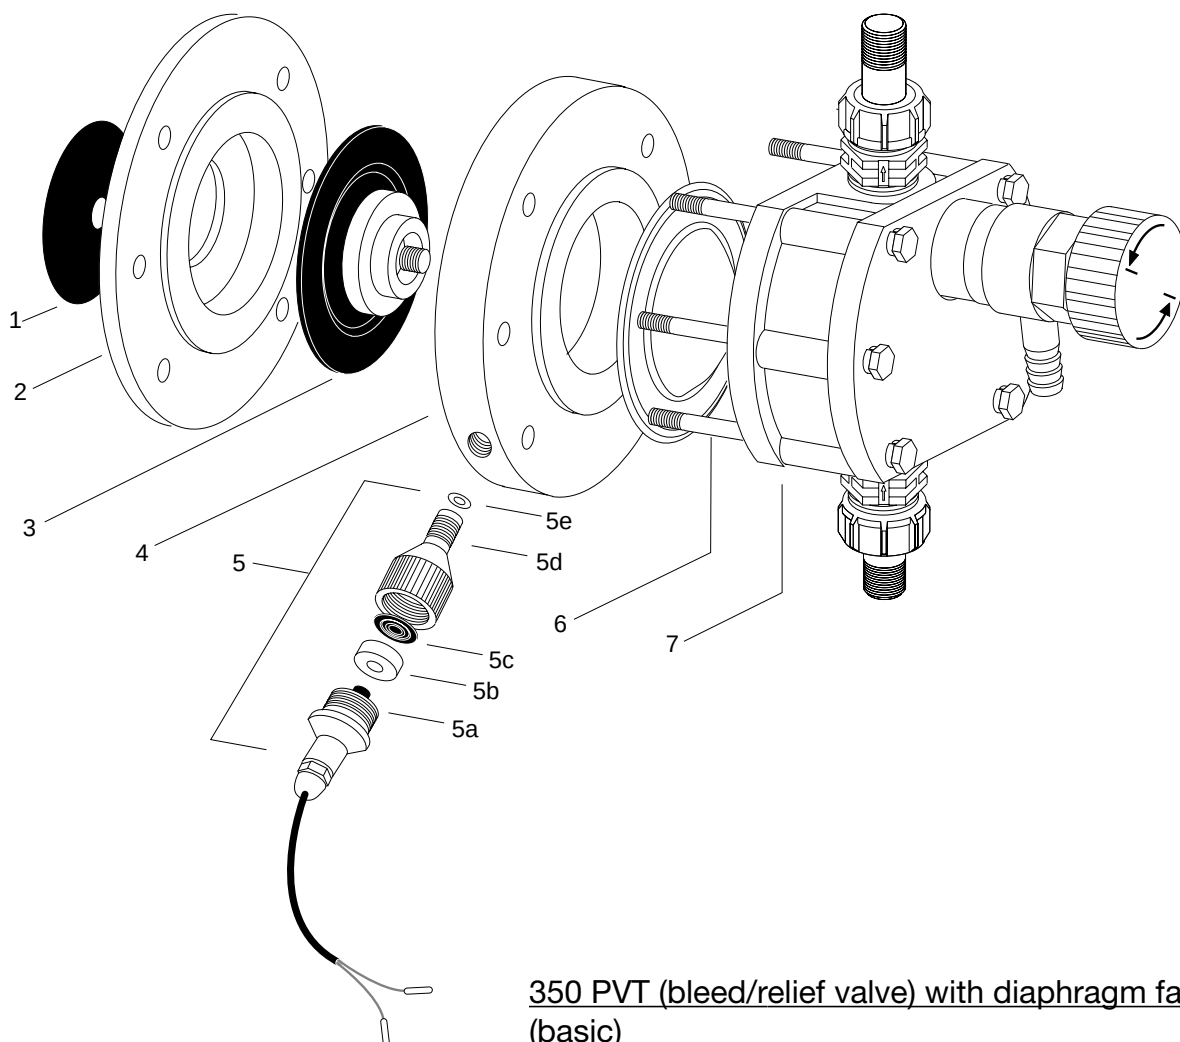
- 1 Safety diaphragm
- 2 Backplate
- 3 Secondary containment diaphragm and hub
- 4 Leak detection spacer
- 5 Leak detection pressure switch assembly
  - a Pressure switch
  - b Spacer
  - c Diaphragm
  - d Body
  - e Gasket
- 6 Diaphragm
- 7 Pump head
